Valve Inspection Report

Includes inspections between: 15.2.2022 - 15.2.2022

Valve Inspection Report #1

Valve Inspection Report #2

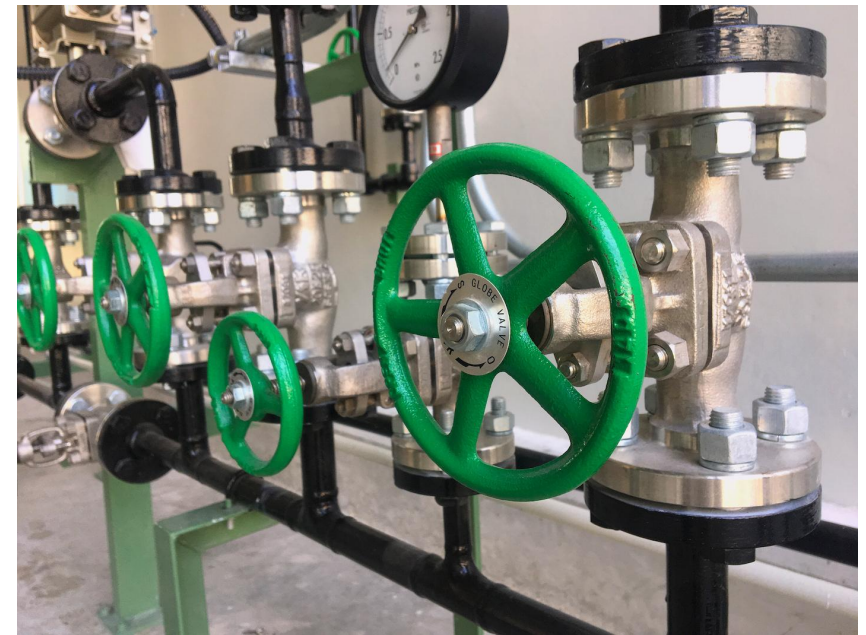
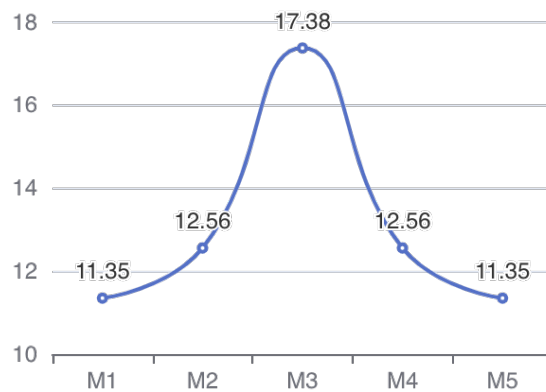
Customer: Senseven
Plant: Vienna
Date: 15.02.22, 08:43
Identifier: 8ME1631OP
Valve Type: Plug
Medium: Gas (Gaseous)
P. U/D: 10 / -
Result: **Leak**

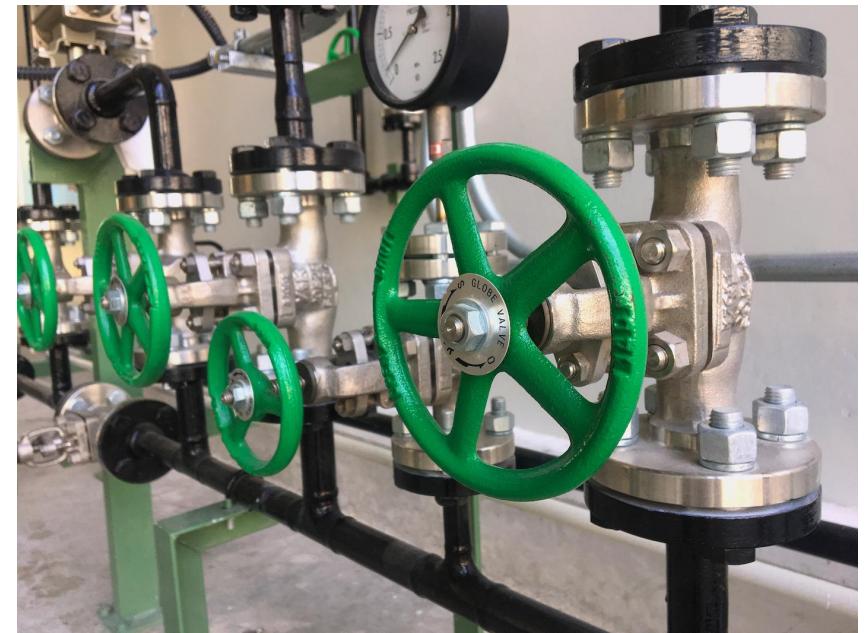
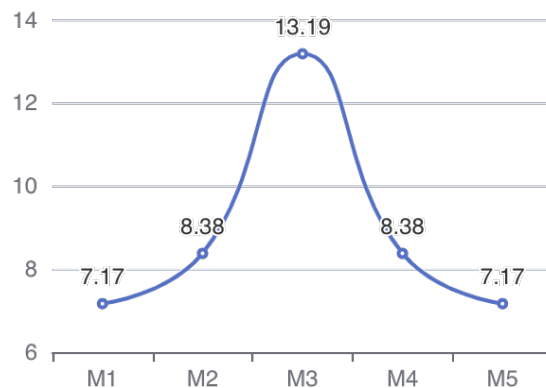
Customer: Senseven
Plant: Vienna
Date: 15.02.22, 08:45
Identifier: 8ME153100
Valve Type: Plug
Medium: Gas (Gaseous)
P. U/D: 15 / -
Result: **Leak**
